MEMORANDUM

TO: Route 138 Corridor Planning Study Committee **1 March, 2000**

RE: Task 4: Review of Existing Traffic, Bicycle, Pedestrian, and Transit Conditions

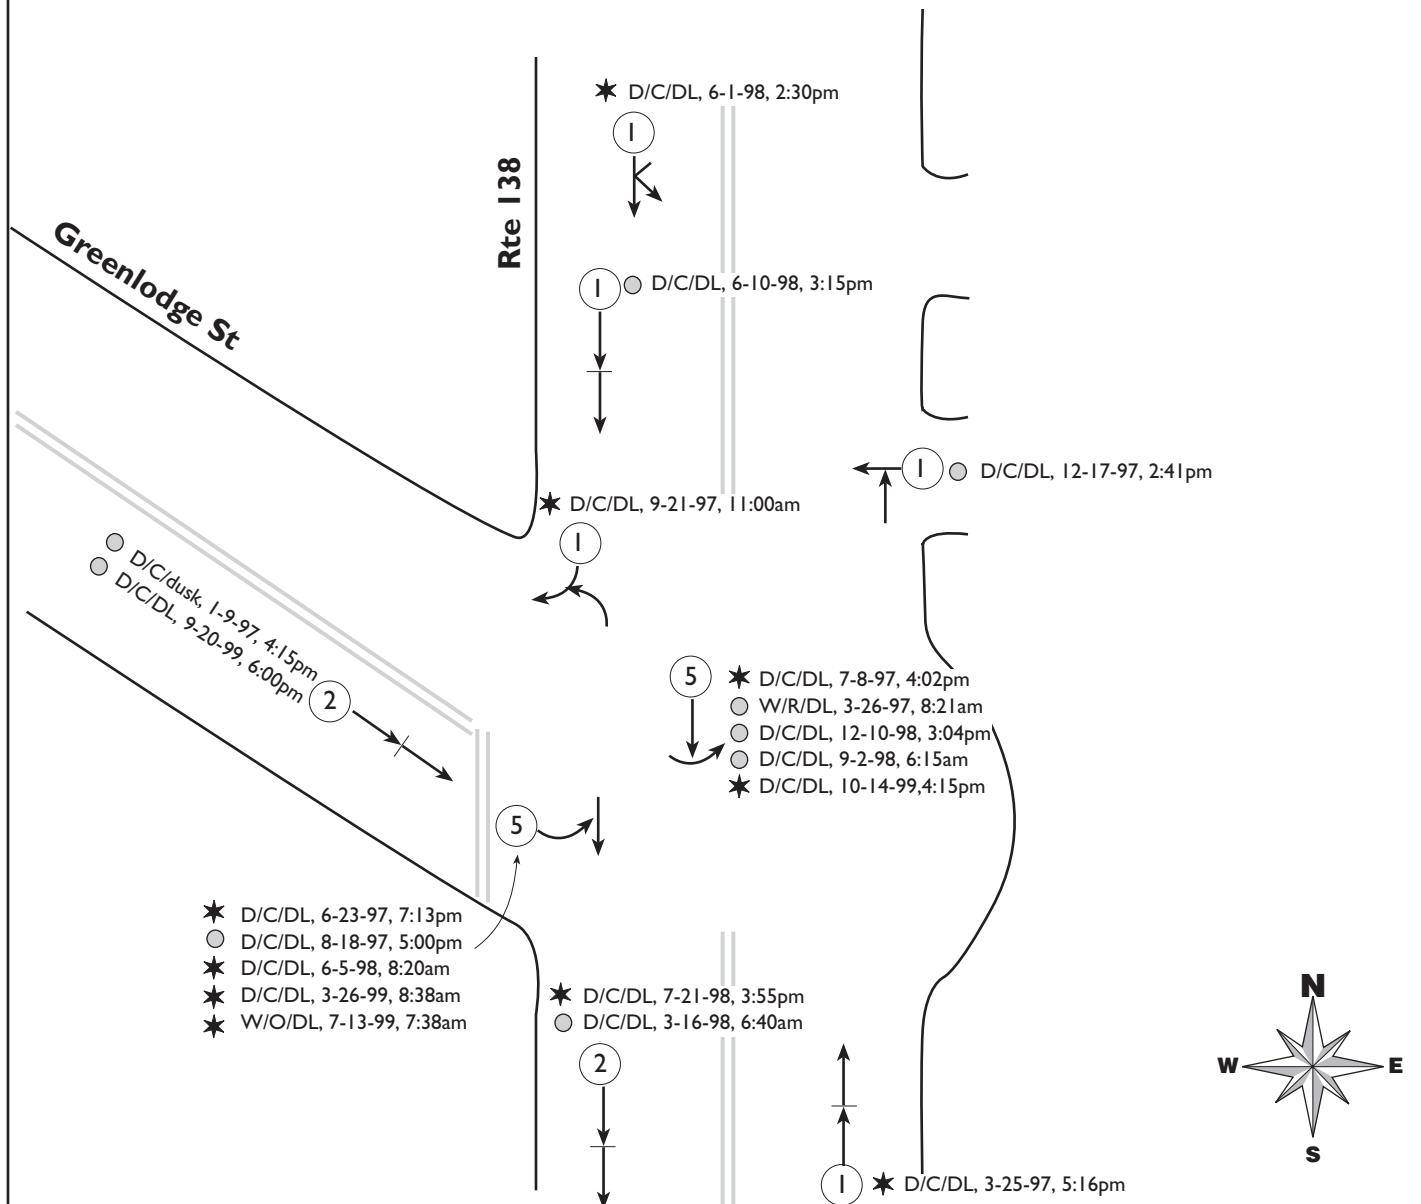
Figure I
Collision Diagram
1/1/97 to 12/31/99
Route 138 @ Greenlodge St
Canton

Based on the police reports, angle and rear end collisions were the most common accident types. A majority of all accidents were angle collisions between a left turning vehicle and a vehicle going straight, while one-third were rear end collisions. More than 50% of the accidents occurred under dry pavement conditions, on weekdays, during clear weather conditions and in daylight hours. On an accidents-per-hour basis, over half of the accidents occurred during the peak hours. Just under half of the accidents involved personal injury. See Figure 1 for a collision diagram of this three-legged intersection.

The skewed geometry and steep grade of the intersection of these two roadways are major factors in the number of accidents occurring. The angle at which Greenlodge Street intersects Route 138 forces exiting vehicles making a left turn onto Route 138 to nearly enter the southbound approach. High speeds on Route 138 (30-38 mph in the peak hours, higher in the off-peak) also contribute to the difficulty for left turning vehicles to exit from Greenlodge Street.

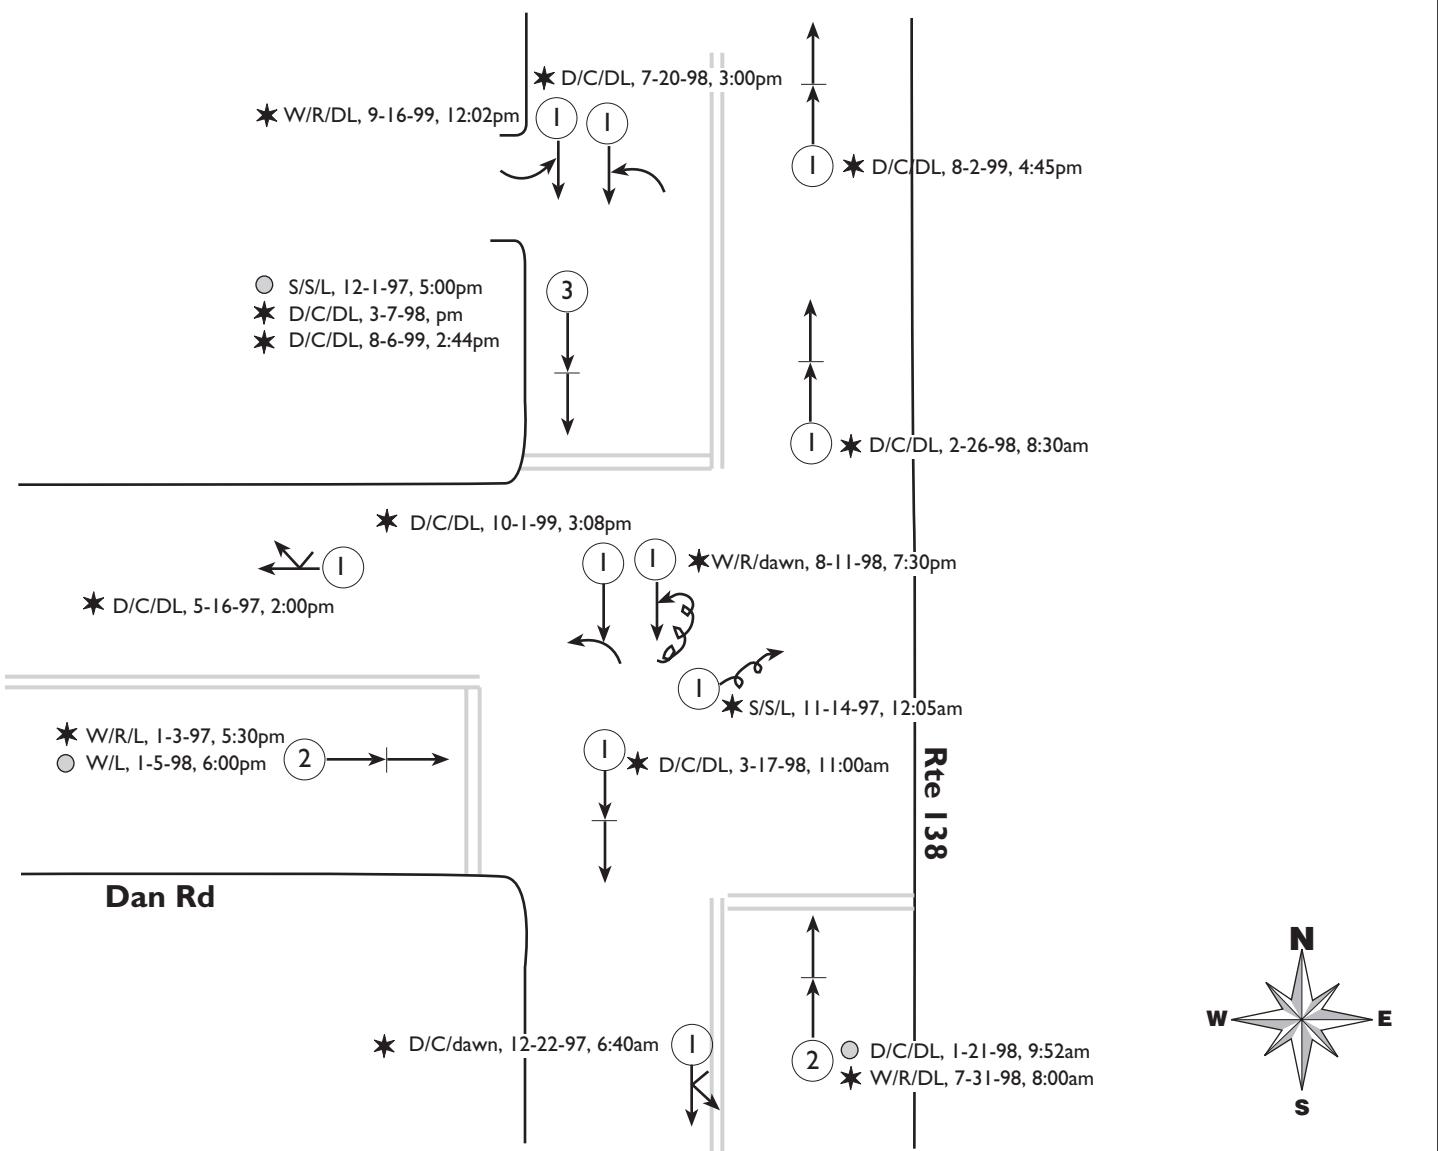
Figure 2
Collision Diagram
1/1/97 to 12/31/99
Route 138 @ Dan Rd
Canton

A total of 17 accidents were reported during 1997–1999 at this signalized intersection, an average of 5.7 accidents per year. Based on the accident information obtained, just over half of the accidents were rear end collisions, common at signalized intersections. Two of the accidents resulted from out of control vehicles. More than 50% of the accidents occurred under dry pavement conditions, on weekdays, during clear weather, and in daylight hours. On an accidents-per-hour basis, two-thirds of the accidents happened during the off peak hours. Only three of seventeen accidents involved personal injury (see Table 8).

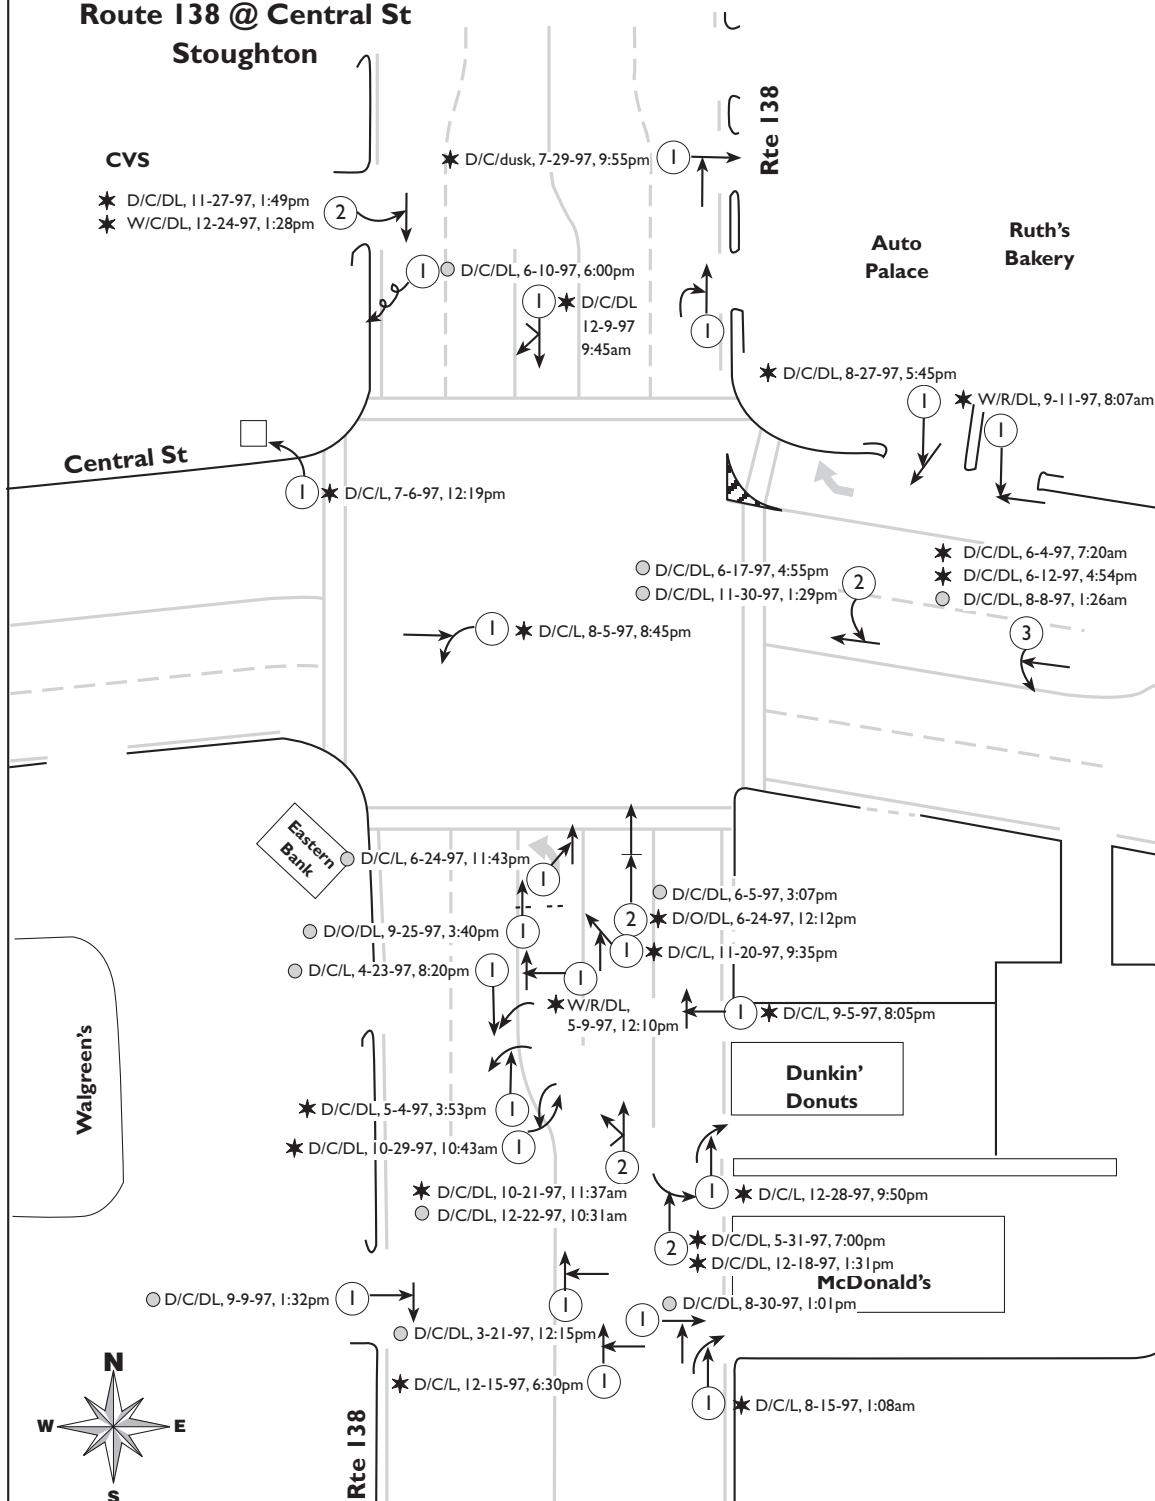
Figure 3a
Collision Diagram
1/1/97 to 12/31/97
Route 138 @ Central St
Stoughton

One hundred nineteen accidents were reported during 1997 through 1999 within 200 feet of the intersection⁷. There were 35, 45, and 39 accidents during the years 1997, 1998 and 1999, respectively. The accident data is summarized in Table 9. This table shows that angle collisions were by far the most common (82%). Three-fourths of the accidents occurred under dry pavement conditions, on weekdays, during clear weather conditions, and in daylight hours. On an accidents-per-hour basis, most accidents occurred during the off peak. One third of the accidents involved personal injury. The collision diagrams are presented in Figures 3a through 3c.

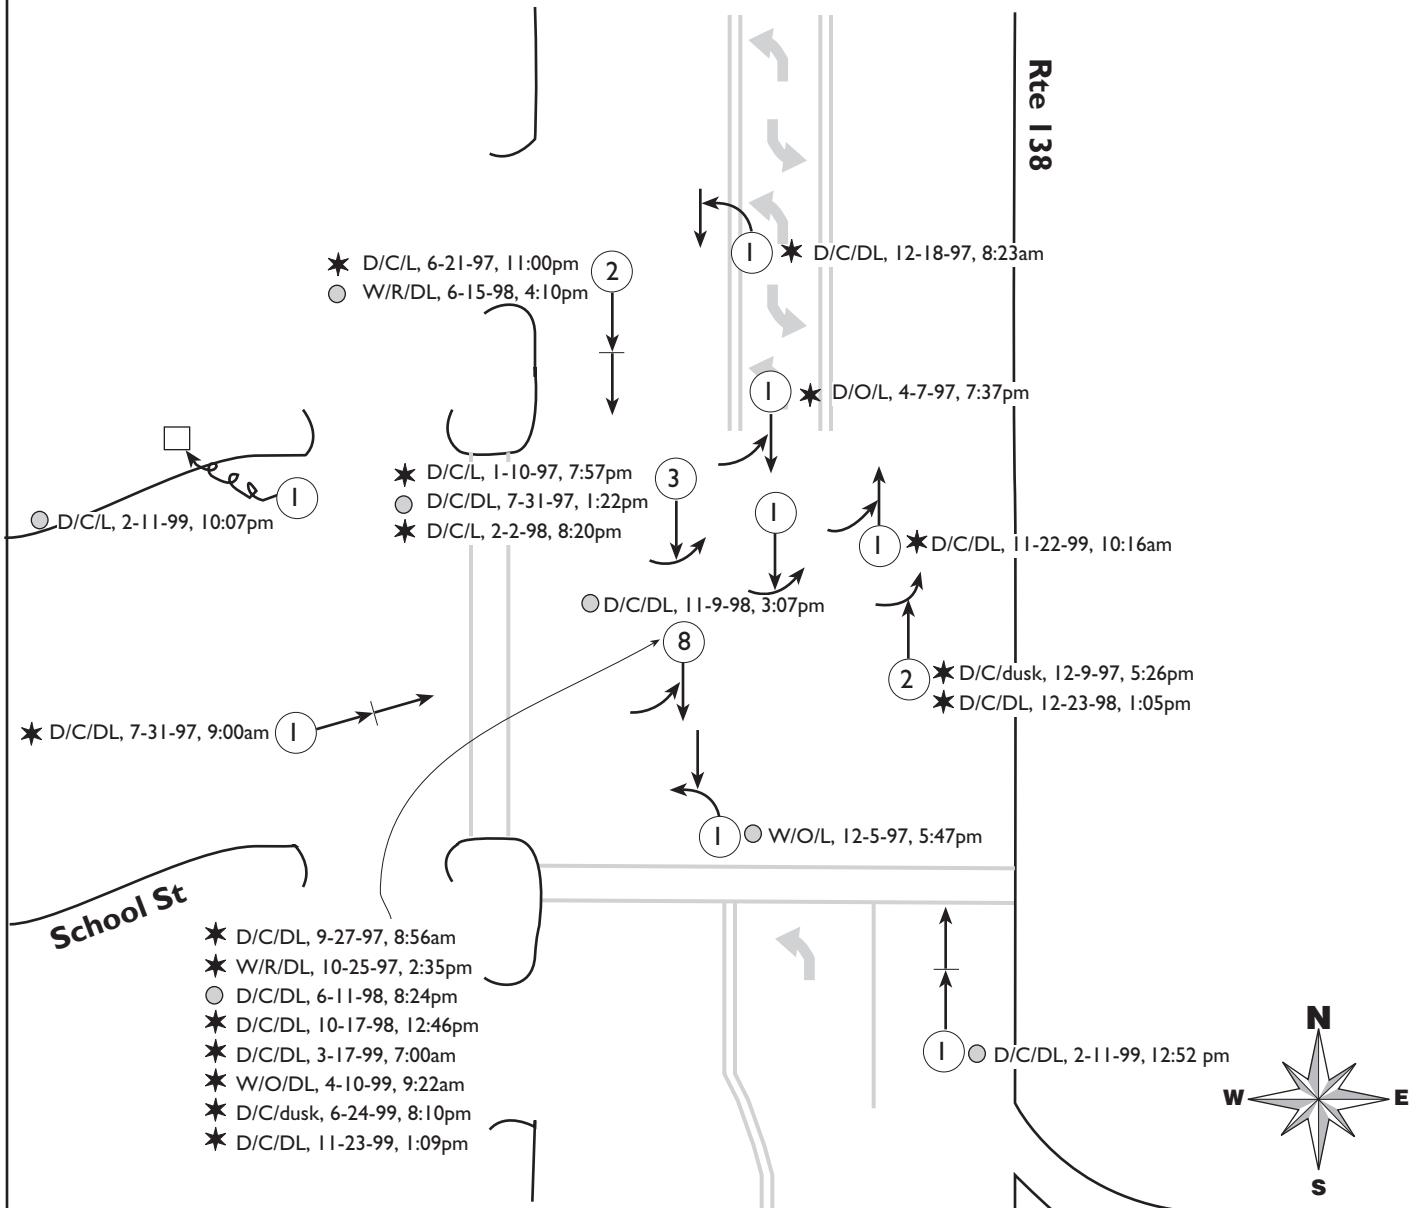
Figure 4
Collision Diagram
1/1/97 to 12/31/99
Route 138 @ School St
Stoughton

A total of 23 accidents were recorded during the three-year period 1997 through 1999. During these three years, there were 10, 6, and 7 accidents, respectively, an average of 7.7 accidents per year. The accident data is summarized in Table 10. Based on the accident reports, angle collisions were by far the most common accident types. Over 50% of the accidents occurred under dry pavement conditions, on weekdays, during clear weather, and in daylight hours. On an accidents-per-hour basis, most accidents happened during the off peak hours. Almost a third of the accidents involved personal injury.

The major reason for the high number of angle collisions at this location seems to be due to the limited sight distance of the Route 138 approaches for vehicles on School Street. This appears to be directly related to the geometric configuration of the intersection, a three-legged intersection with a two-way left-turn lane on the Route 138 southbound approach, and an exclusive left-turn lane on the northbound approach. The sight distance to safely cross the intersection seems to be inadequate, due to the added roadway width from the two left-turn lane approaches. Additionally, because of the moderate to high speeds (18–32 mph in the peak hours, higher during off-peak), it is difficult for School Street traffic to find acceptable gaps to merge safely into the Route 138 traffic. In some cases drivers may miscalculate acceptable gaps. At other times, perhaps out of frustration, drivers may rush onto Route 138, particularly vehicles making left turns. As seen in Figure 4, sixteen of the twenty-three accidents involve left turns from School Street colliding with either southbound or northbound Route 138 vehicles.

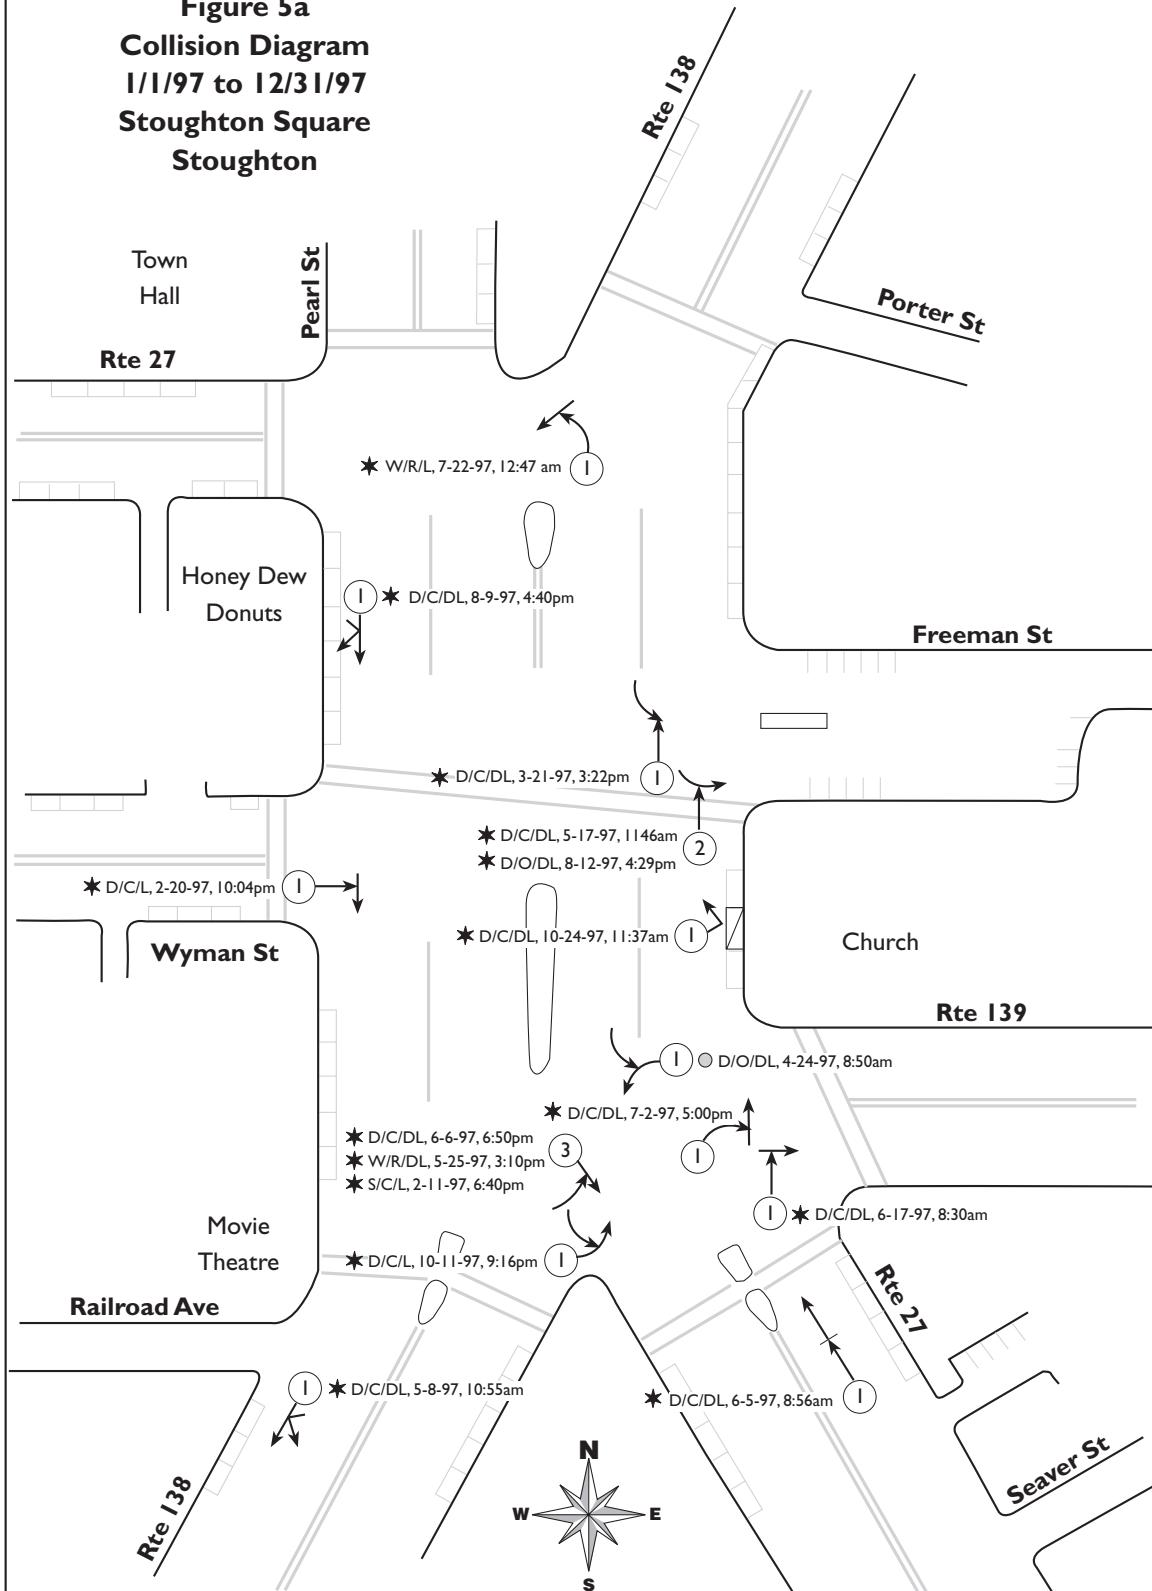
Figure 5a
Collision Diagram
1/1/97 to 12/31/97
Stoughton Square
Stoughton

Stoughton Square is unsignalized, and is a combination of eight streets merging into one 370 feet long area. It can be quite precarious to traverse during periods of heavy traffic, particularly for side street left turns onto Route 138/Route 27 during heavy northbound and southbound traffic flows. Side street vehicles must also traverse extensive pavement area (two or three lanes) to make left turns. Further, weaving movements within the Square sometimes result in chaotic conditions. Other factors contributing to angle collisions are from the confusion caused by signs that restrict left turns during certain periods of the day, and from parking within the Square. Rear end collisions at this location may occur due to wet pavement conditions, high stop-and-go traffic volumes, and delays associated with turning movements.

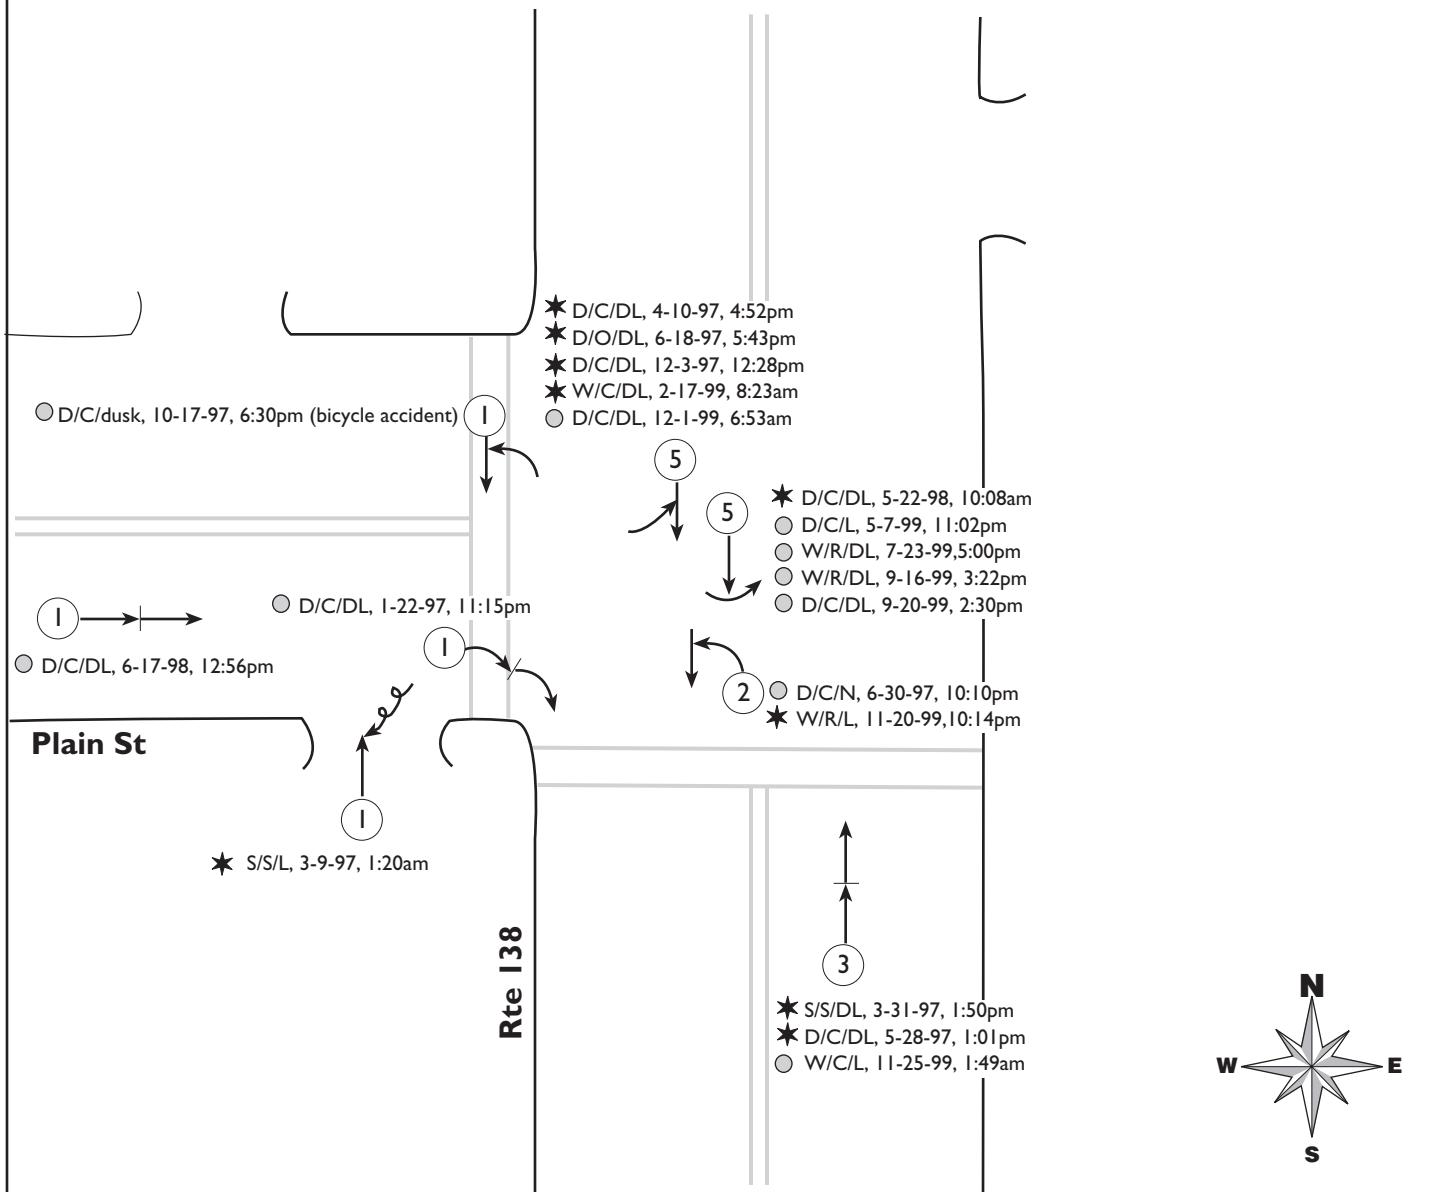
Figure 6
Collision Diagram
1/1/97 to 12/31/99
Route 138 @ Plain St
Stoughton

Based on the accident reports, angle and rear end collisions were the most common accident types, 68% and 26%, respectively. More than half of the accidents occurred under dry pavement conditions, on weekdays, during clear weather conditions, and in daylight hours. On a per-hour basis, three-fourths of the accidents occurred during the off peak hours. Just over half of the accidents involved personal injury. Figure 6 shows the collision diagram for this location.

The reason for the high number of angle collisions at this location is due to vehicles turning left from Plain Street to Route 138 northbound. High speeds on Route 138, especially during off peak hours, are likely factors as well (21–32 mph in the peak hours, higher in the off-peak) The causes for rear end accidents are stop-and-go conditions and left-turning vehicles waiting on Route 138 northbound to turn onto Plain Street.
