FINAL ENERGY AUDIT REPORT

JANUARY 8, 2024

**Milton Police Department
40 Highland Street
Milton, MA**

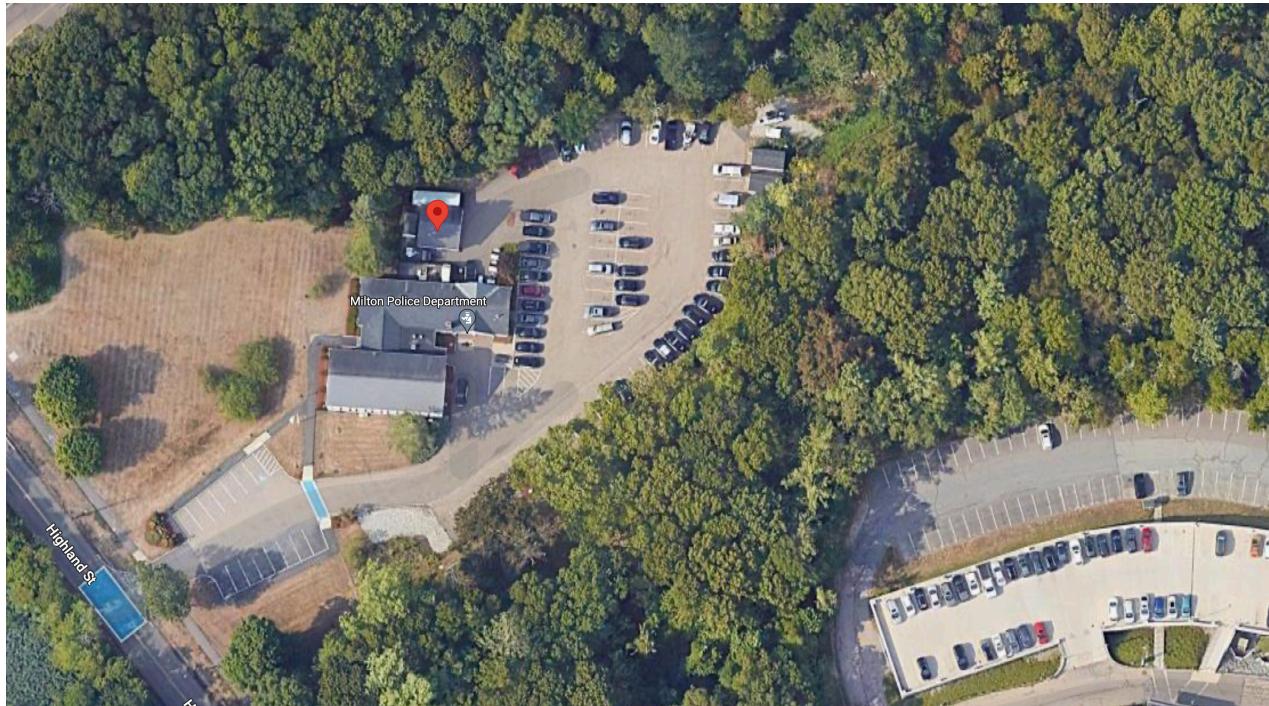
We generally start by maximizing the amount of solar PV that will fit at each facility. Referring to the aerial image below, the rooftop arrays would occupy space on each of the three south/southeast facing roof slopes. Due to significant tree and building shading, A canopy would be placed over the eight parking spaces to the left of the main entry from Highland Street. The ground mount array would be set back from the street in the grass field to the left of the building as you enter from the property. It would be roughly the shape of a half football field. The combined kW of the three PV location types is 214: (15kW roof, 20kW canopy and 142 kW ground). They would provide almost 150% of the Police Department's current annual kWh energy usage allowing for net metering and community solar/sharing opportunities. Without the ground mount array about 28% of the annual kWh would be provided.

Our primary recommendation is to install several solar PV arrays: three rooftop, two parking lot canopy and one ground mount as well as a “battery energy storage system” (BESS), sized to meet the current (or anticipated future) peak monthly coincident electricity demand of the Police Department (as historically recorded on the two master electric meters).
