**CTPS**  
**Route 138 Corridor**  
**Planning Study**

**Figure 13**  
**Route 138 at Blockbuster/Applebee's**  
**Driveway (Stoughton)**  
— **Suggested Improvements**  
— **1999 AM (PM) Peak Hour Turning Movements**

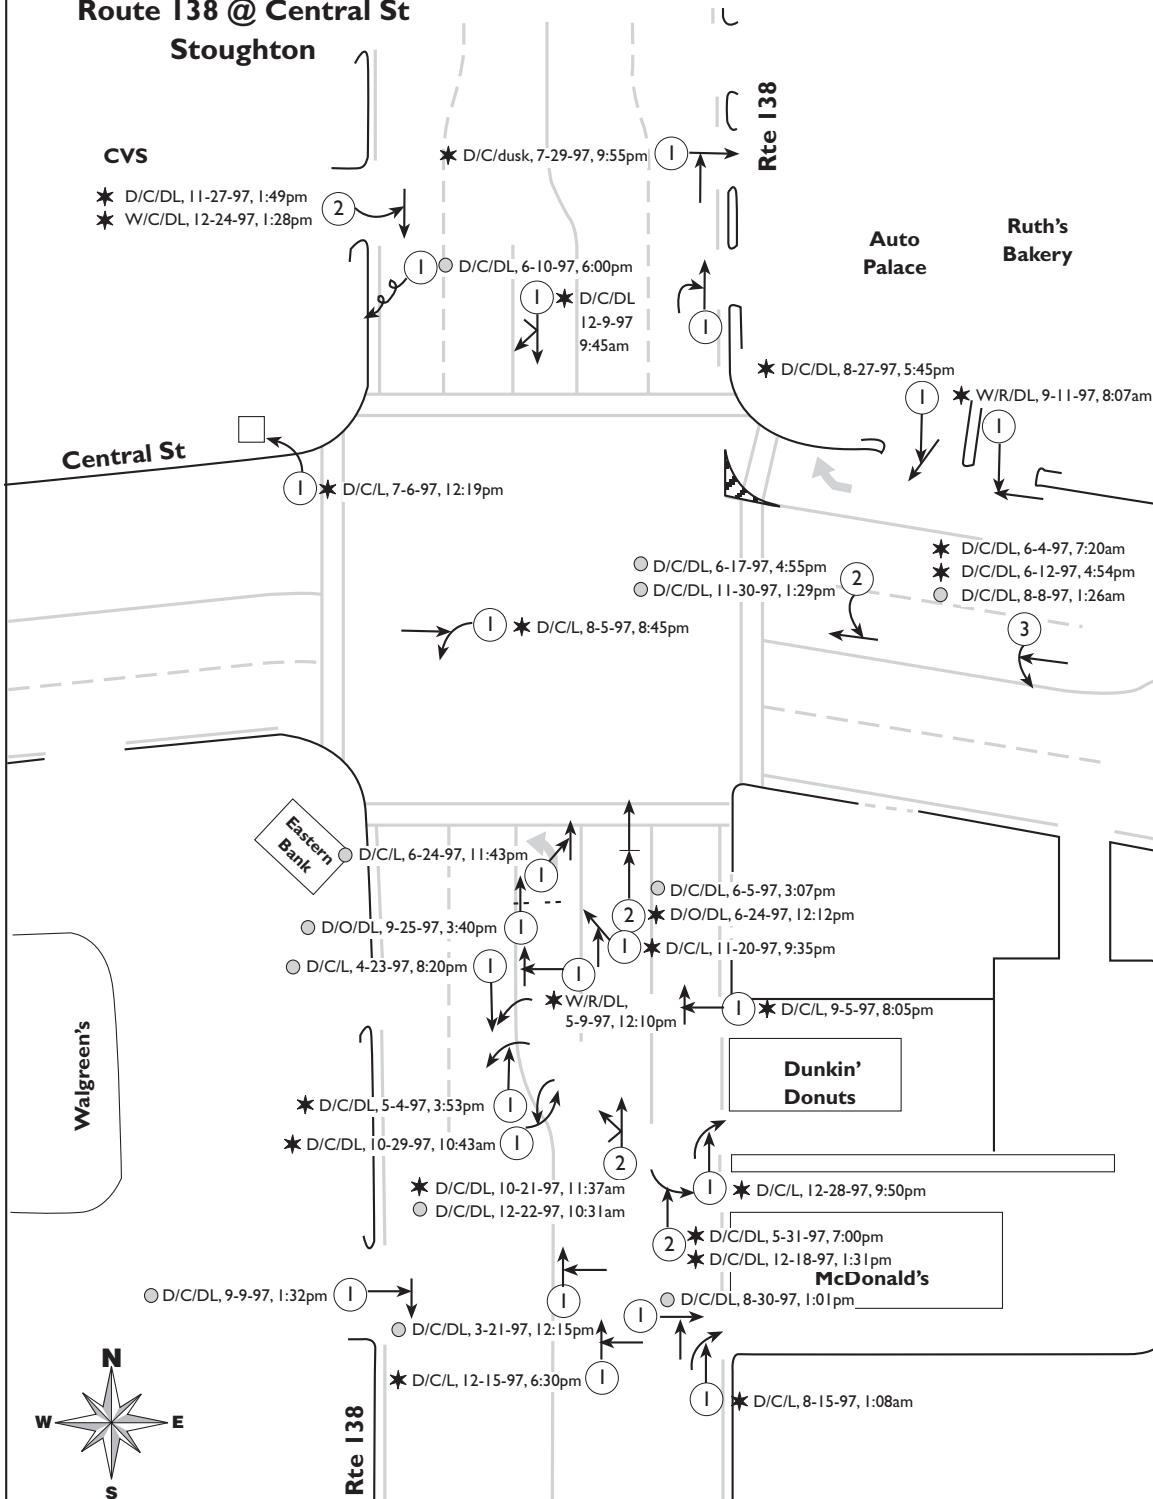
**Figure 12a**  
**Collision Diagram**  
**1/1/97 to 12/31/97**  
**Route 138 @ Central St**  
**Stoughton**

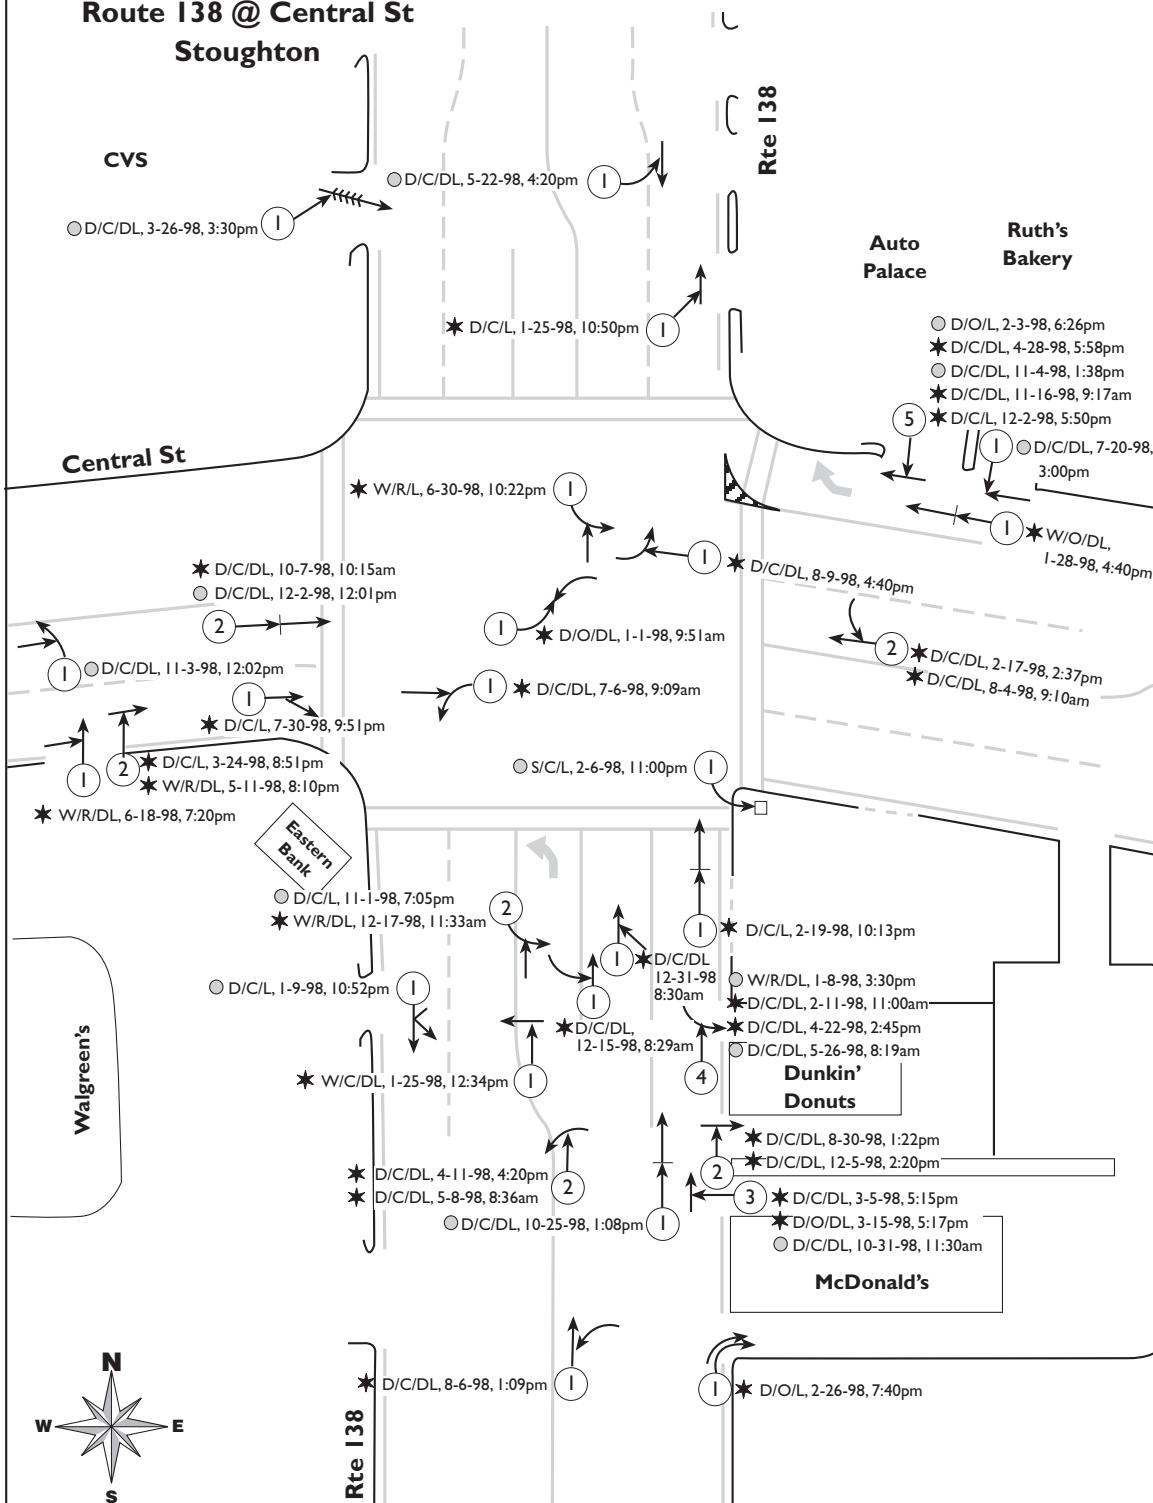
**Figure 12b**  
**Collision Diagram**  
**1/1/98 to 12/31/98**  
**Route 138 @ Central St**  
**Stoughton**

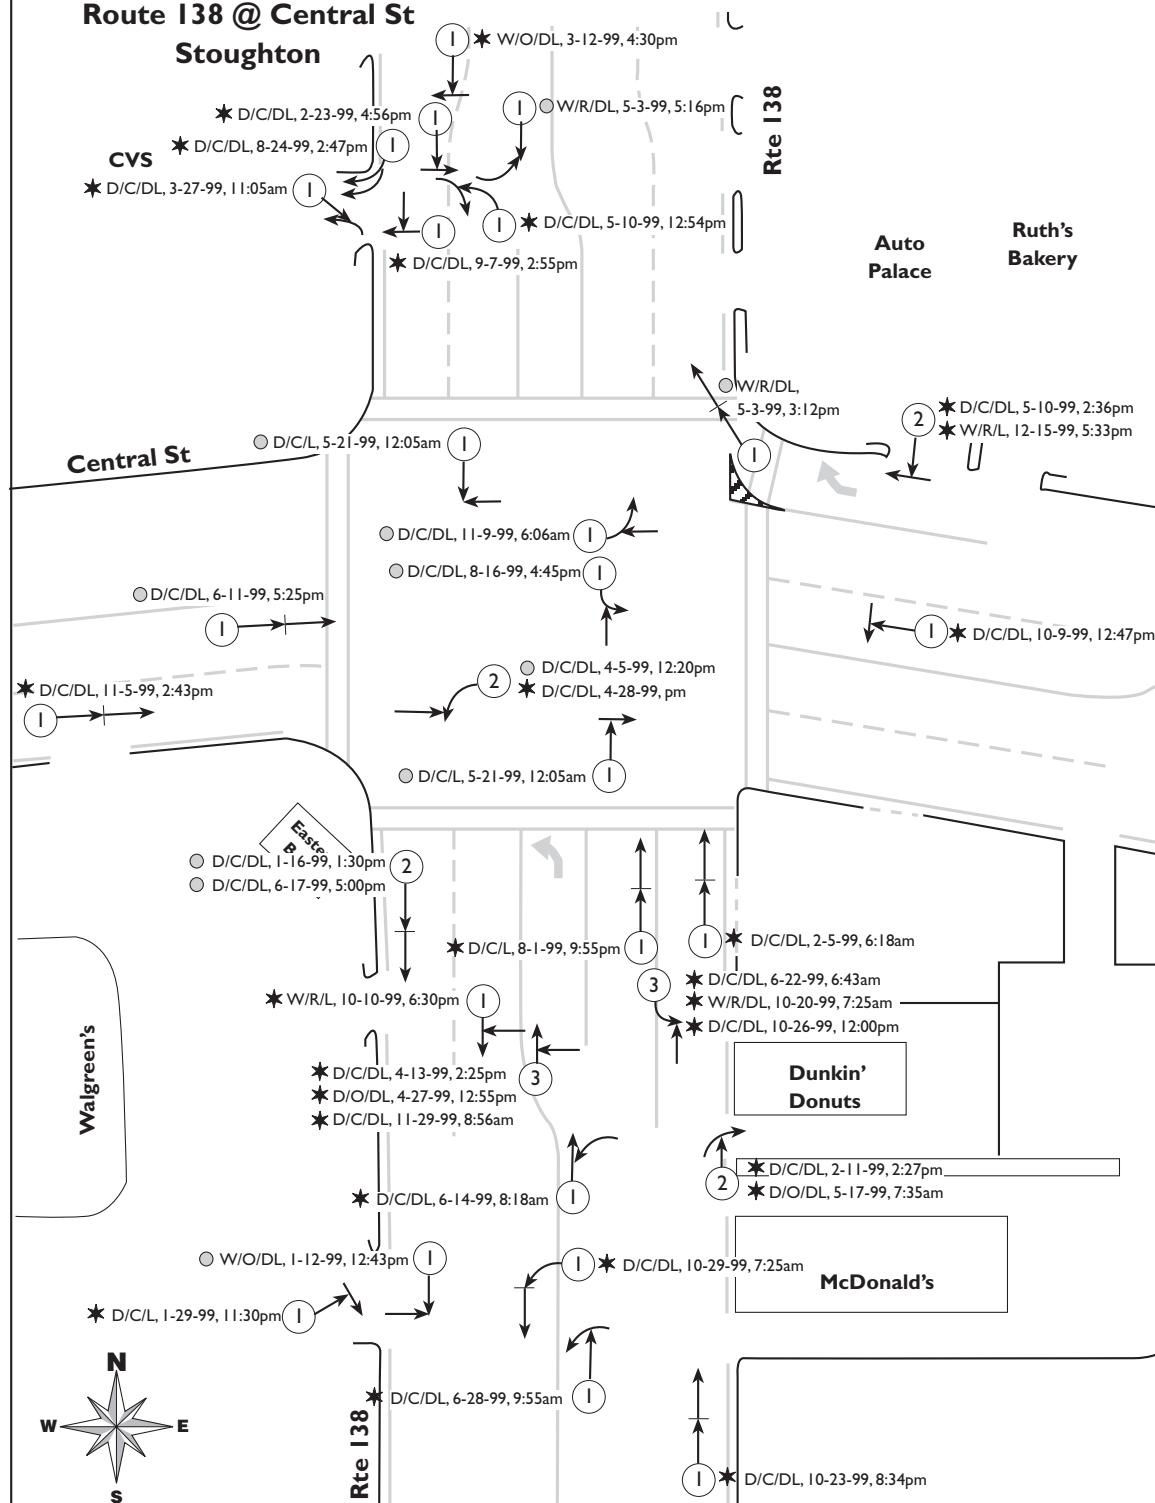
**Figure 12c**  
**Collision Diagram**  
**1/1/99 to 12/31/99**  
**Route 138 @ Central St**

ROUTE 138/CENTRAL STREET:		1999	2020 No-Build	2020 Build
•	Intersection LOS/Delay (1)	AM: F / *	F / *	F / *
	PM: F / *	F / *	F / *	F / *
•	Number of Collisions, 1997–1999 (Stoughton Police): 119 (39.7 per year)			
•	Jurisdiction of Improvement(s): MassHighway, Town of Stoughton, business owners

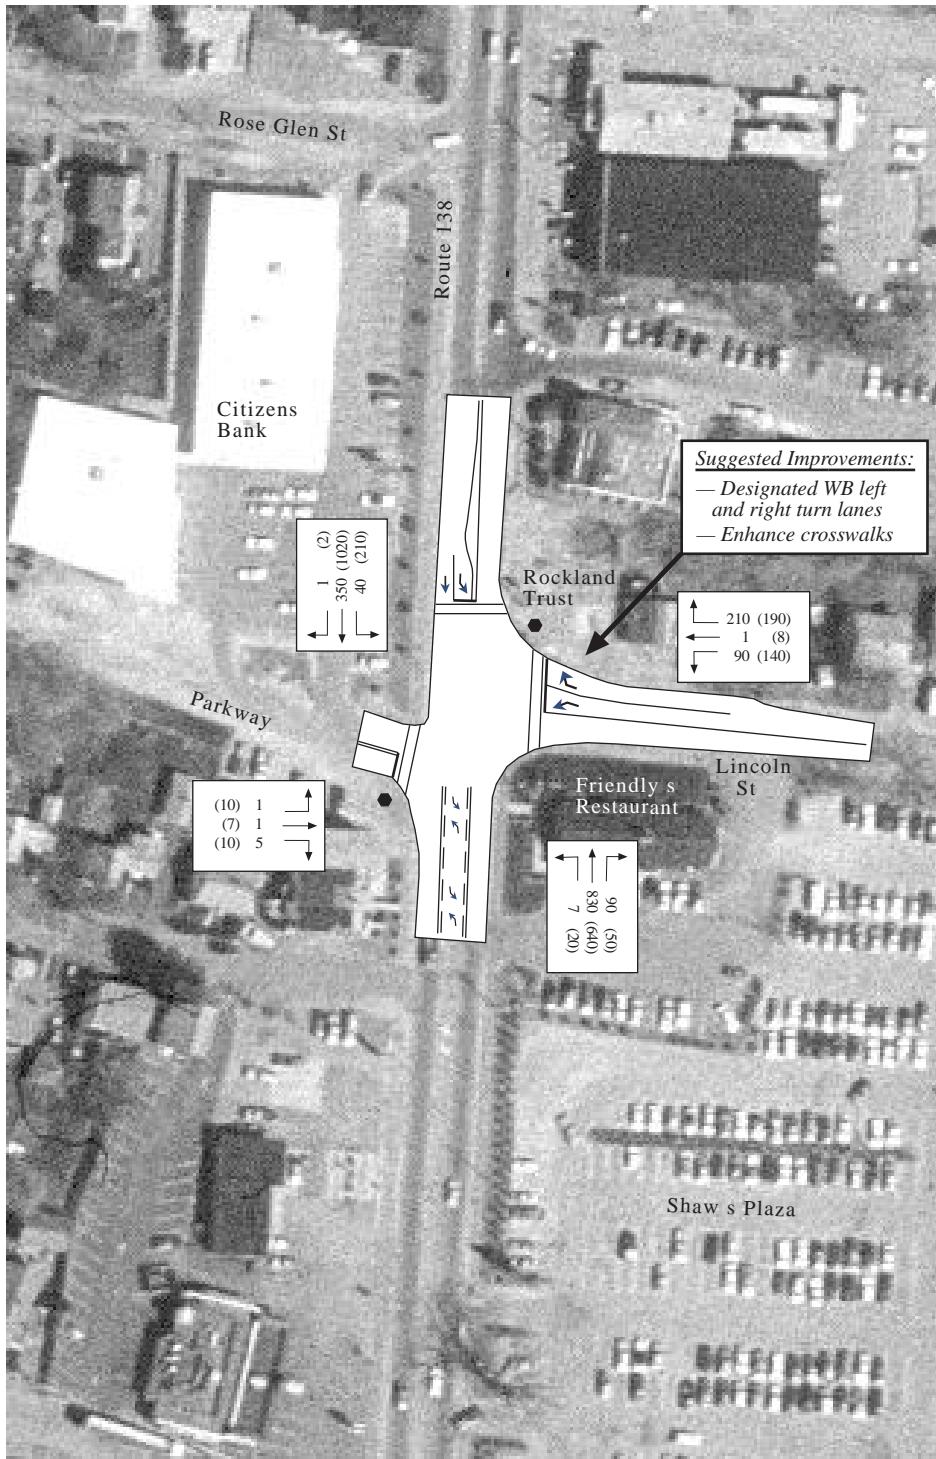
**Figure 14**

**SCHEMATIC--**  
Not to scale

**Route 138 at Lincoln St (Stoughton)**  
**— Suggested Intersection Improvements**  
**— 1999 AM (PM) Peak Hour Turning Movements**

**Recommendation:** During field reconnaissance, it was noticed that there were already left and right turns taking place simultaneously from Lincoln Street onto Route 138. However, the existing “lanes” are too narrow to comfortably accommodate two lanes of turning vehicles. Therefore, *it is recommended that some widening of Lincoln Street take place in order to create 12-ft exclusive left- and right-turn lanes. In addition, existing crosswalks at this intersection should be made more prominent.* Since Lincoln Street is a town facility, and Route 138 becomes a state facility north of the intersection, the recommended improvements fall under local jurisdiction. Figure 14 shows existing turning movements and the recommended improvements.

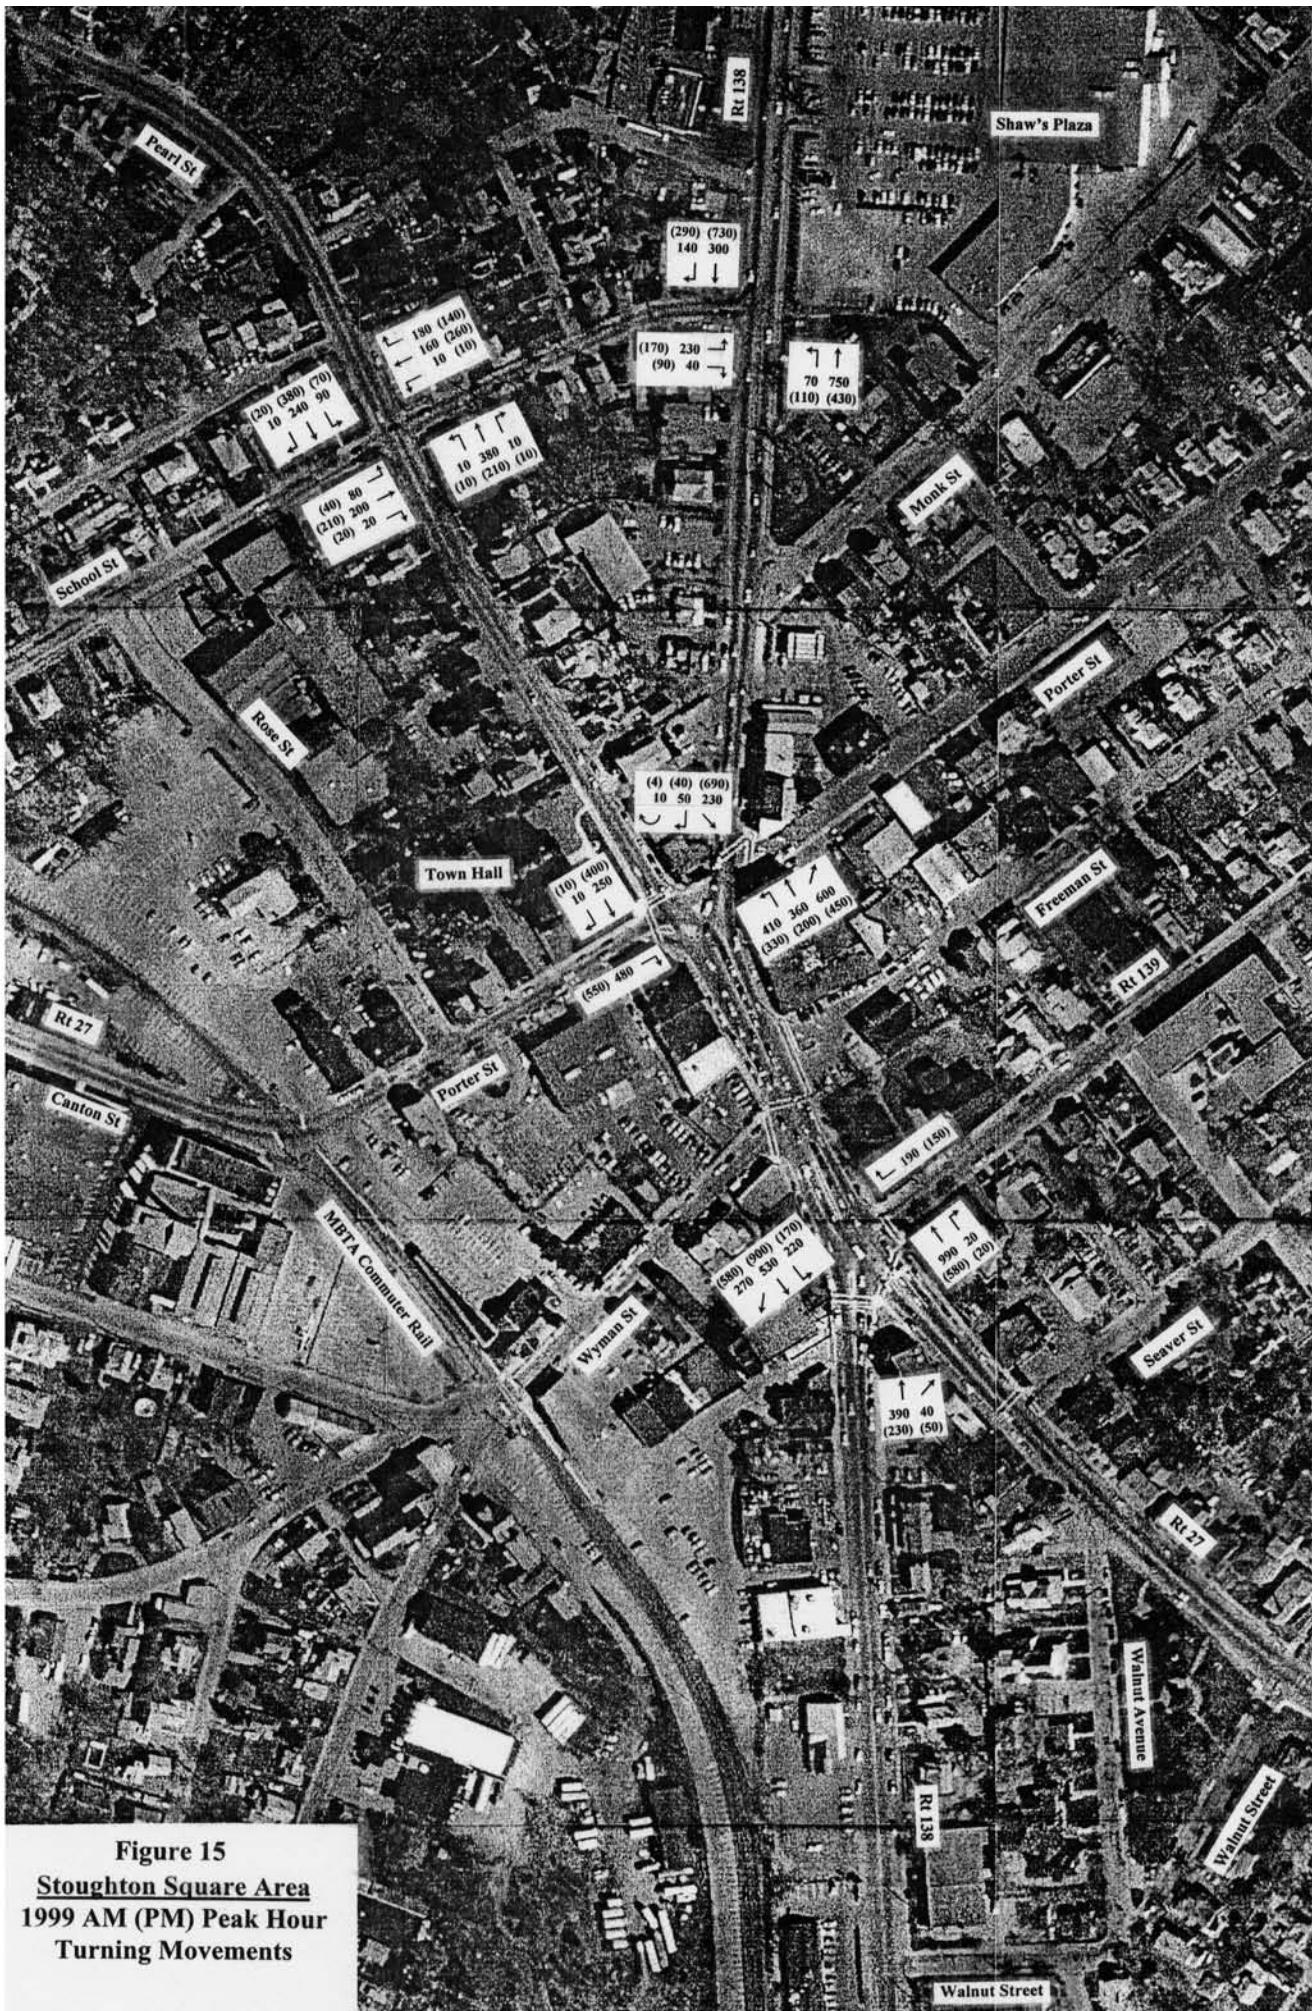
**Figure 15**  
**Stoughton Square Area**  
**1999 AM (PM) Peak Hour**  
**Turning Movements**

**Recommendation:** Currently, this is an unsignalized three-way intersection (see Figure 15 for 1999 AM and PM turning movements). School Street connects Route 138 to Pearl Street, another north-south roadway, about 500 feet to the west. There were 23 accidents recorded at Route 138 at School Street during 1997 through 1999. The majority of accidents (18) were angle collisions, and of these, 16 involved vehicles turning left from School Street to Route 138 northbound (see Figure 16).
