STOUGHTON

Route 138 Corridor
Planning Study

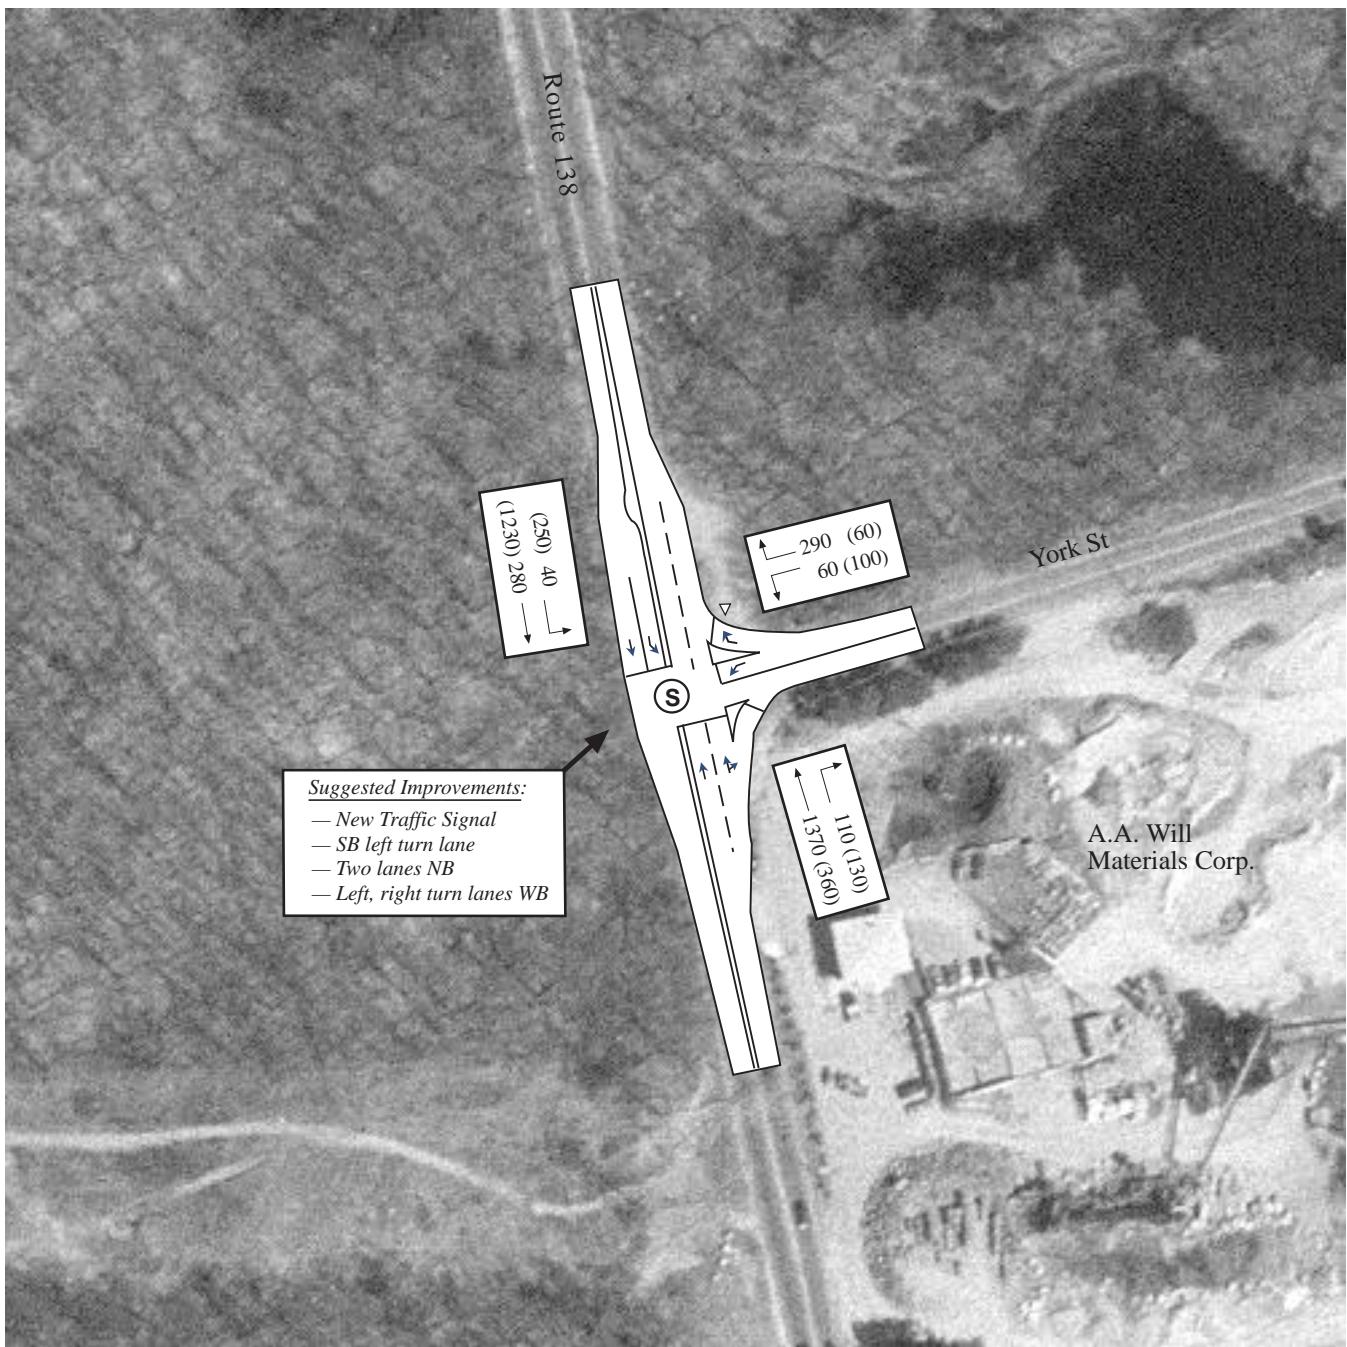
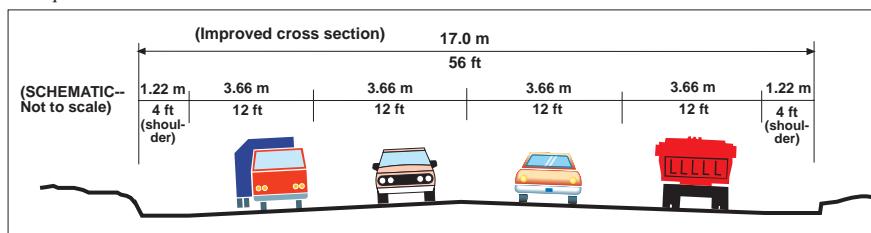
SCHEMATIC--Not to scale

Route 138 at York St (Stoughton)
— *Suggested Intersection Improvements*
— *1999 AM (PM) Peak Hour Turning Movements*

Recommendation: This is a three-way intersection, with Route 138 on a steep incline. Two-way daily traffic volumes on Route 138 are about 24,000 at the Canton-Stoughton line, located 1,500 ft to the north of York Street. Figure 8 shows the 1999 AM and PM peak hour turning movements. Accident data from the Mass. Registry's 1995–1997 files listed 18 collisions, an average of 6.0 per year.

Therefore, it is recommended that a traffic signal be installed at this intersection. It is also recommended that the intersection be widened to allow a second travel lane northbound, an exclusive left-turn lane southbound, and exclusive left- and right-turn lanes westbound. The added lanes are required to yield acceptable LOS results. A four-lane cross section would result on Route 138, and given an available ROW of 60 ft, there should be ample space for four 12-ft lanes as well as painted shoulders/bicycle lanes on both sides. A “Signal Ahead” warning sign, similar to that recommended in Concern/Recommendation 7, should be installed south of the intersection near the crest of the hill. The recommended improvements would fall under MassHighway’s jurisdiction.

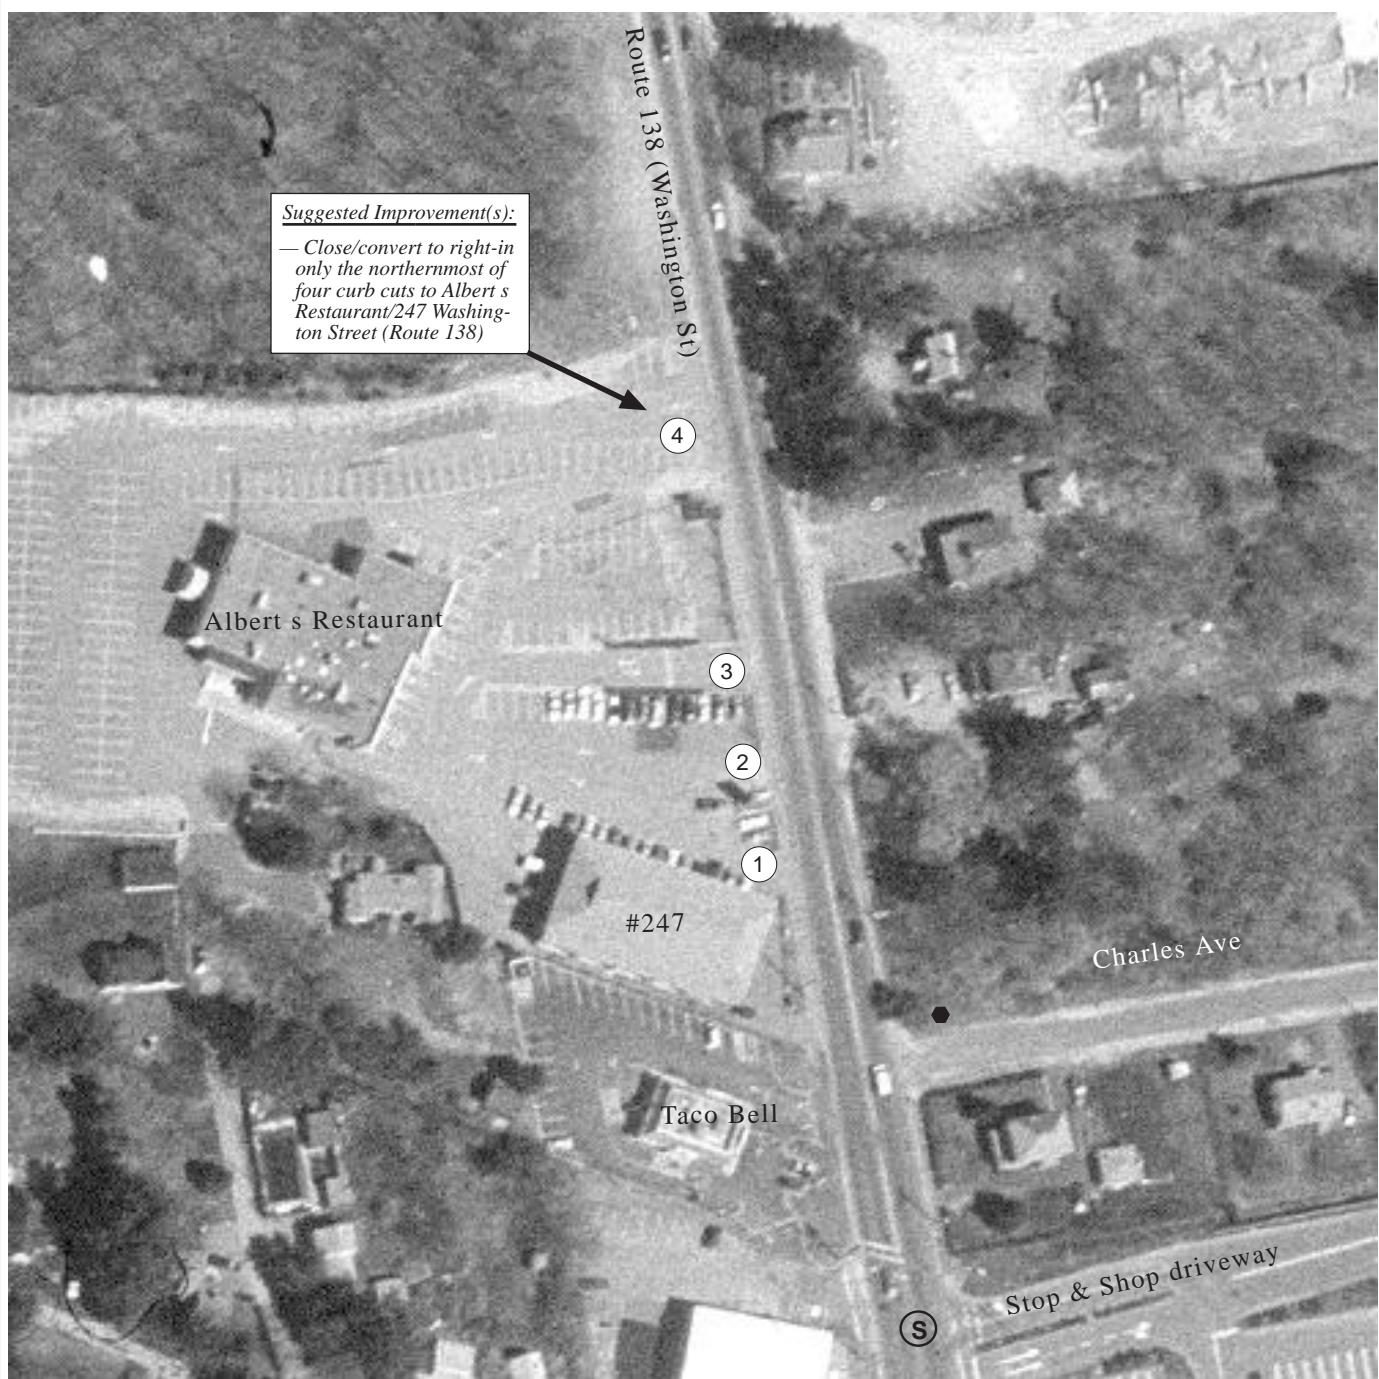
Figure 9

KEY:	S = Signal
● = Stop	F = Flashing red/yellow
▽ = Yield	① = Curb cuts to Albert's Restaurant/ #247 area
↑ SCHEMATIC-- Not to scale

**Route 138 at Albert's Restaurant/#247 (Stoughton)
— Suggested Closing/Altering of One of Four Curb Cuts**

Recommendation: There are four existing curb cuts accessing Albert’s Restaurant and other commercial establishments at #247 Washington Street (Route 138). Since the northernmost of the four driveways is located near a hillcrest, causing insufficient sight distance and potentially unsafe turning movements, *it is recommended that this driveway be closed, or converted to right-in only* (see Figure 9). Some or all of the remaining driveways may need some widening or upgrading should this recommendation be implemented. MassHighway and the town of Stoughton would be involved in adopting this improvement measure.

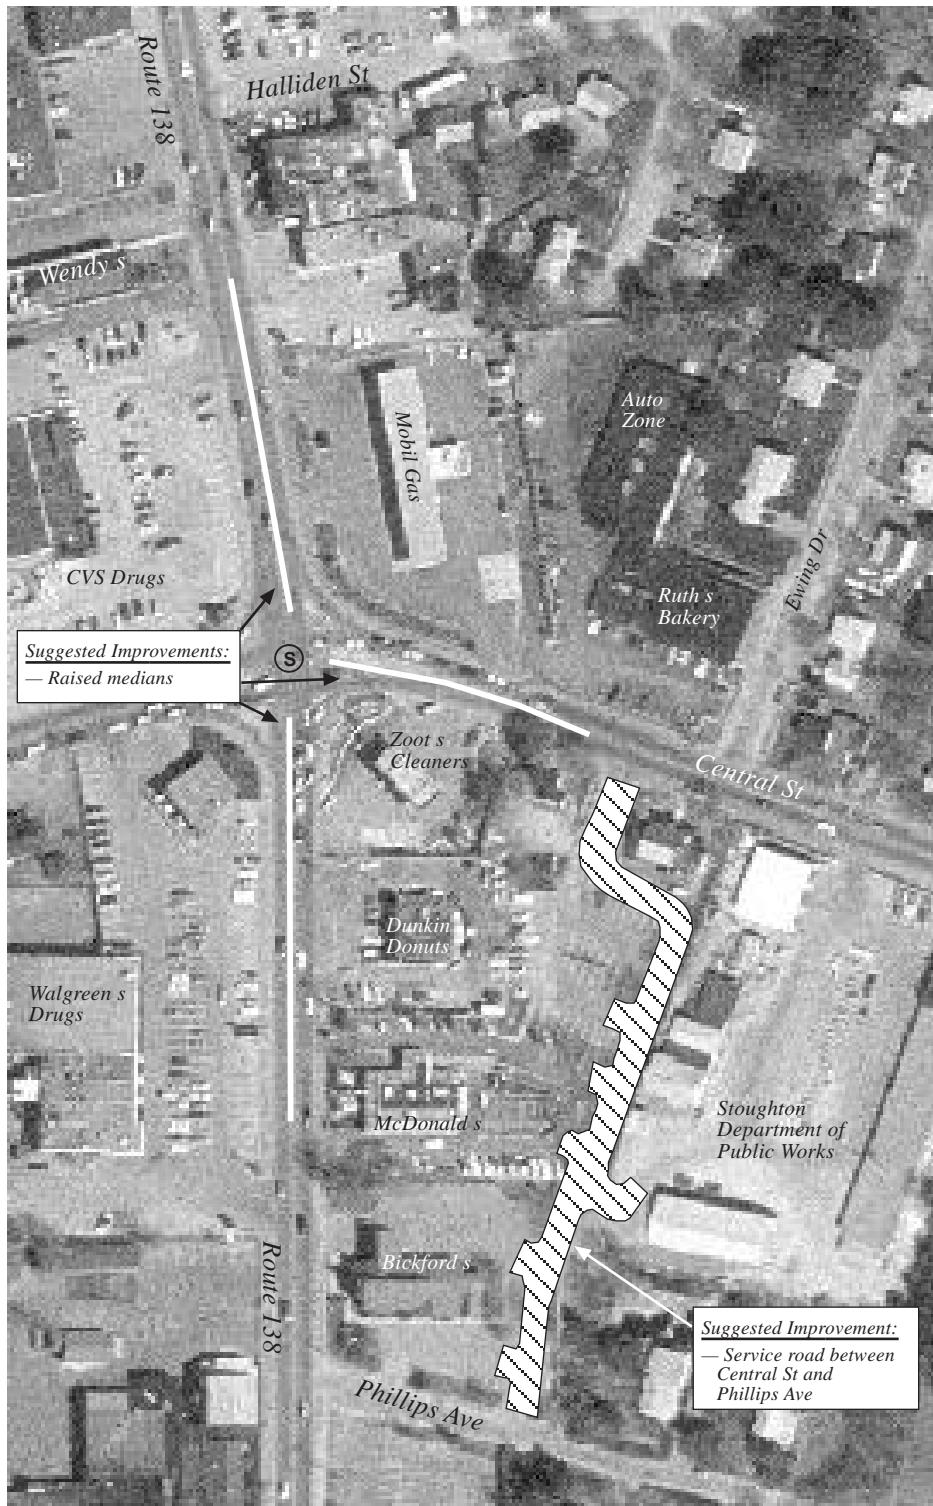
Figure 10
Route 138 at Central St (Stoughton)
— Suggested Raised Medians
— Suggested Service Road

KEY:
 ● = Stop (S) = Signal
 ▽ = Yield (F) = Flashing red/yellow
SCHEMATIC--
 Not to scale

Recommendation: *It is recommended that raised medians, ranging in length from 175 ft to 350 ft, be installed on the southbound, westbound, and northbound approaches to the intersection (see Figure 10).*

It appears that the only means of reducing collisions and congestion is through geometric changes designed to channelize traffic in the general area of the intersection. The recommended improvement of raised medians on the three approaches would eliminate all left turns in and out of Dunkin Donuts, Zoot's Cleaners, CVS's Route 138 driveway (CVS's Central Street driveway would not be affected), and the Auto Zone, Ruth's Bakery, and Mobil gas station.

Since improving safety is the main concern, due to the large number of collisions, the medians are being recommended despite the fact that some businesses may be affected by the improvements. Therefore, *a second, accompanying recommendation is that a service road be created behind the businesses in the southeast quadrant.* This would mitigate the reduced access which the raised medians would effect. McDonald's currently has direct access to Central Street via its second driveway. It is recommended that access to this driveway be made available to Dunkin' Donuts and Bickford's as well, while extending the service road southward to Phillips Avenue.

From the recommended improvements, overall safety levels would improve throughout the intersection. It is acknowledged that the available ROW may not be sufficient to install medians totalling about six feet in width. Currently, there are five travel lanes within a 60-ft ROW. A small strip of land may need to be taken from the southwest quadrant, the parking area in the Walgreen's plaza, in order to accommodate this widening. Jurisdiction for adding the raised medians would be MassHighway's. The recommended service road between Central Street and Phillips Avenue would require cooperation between the various business owners and Stoughton town officials.

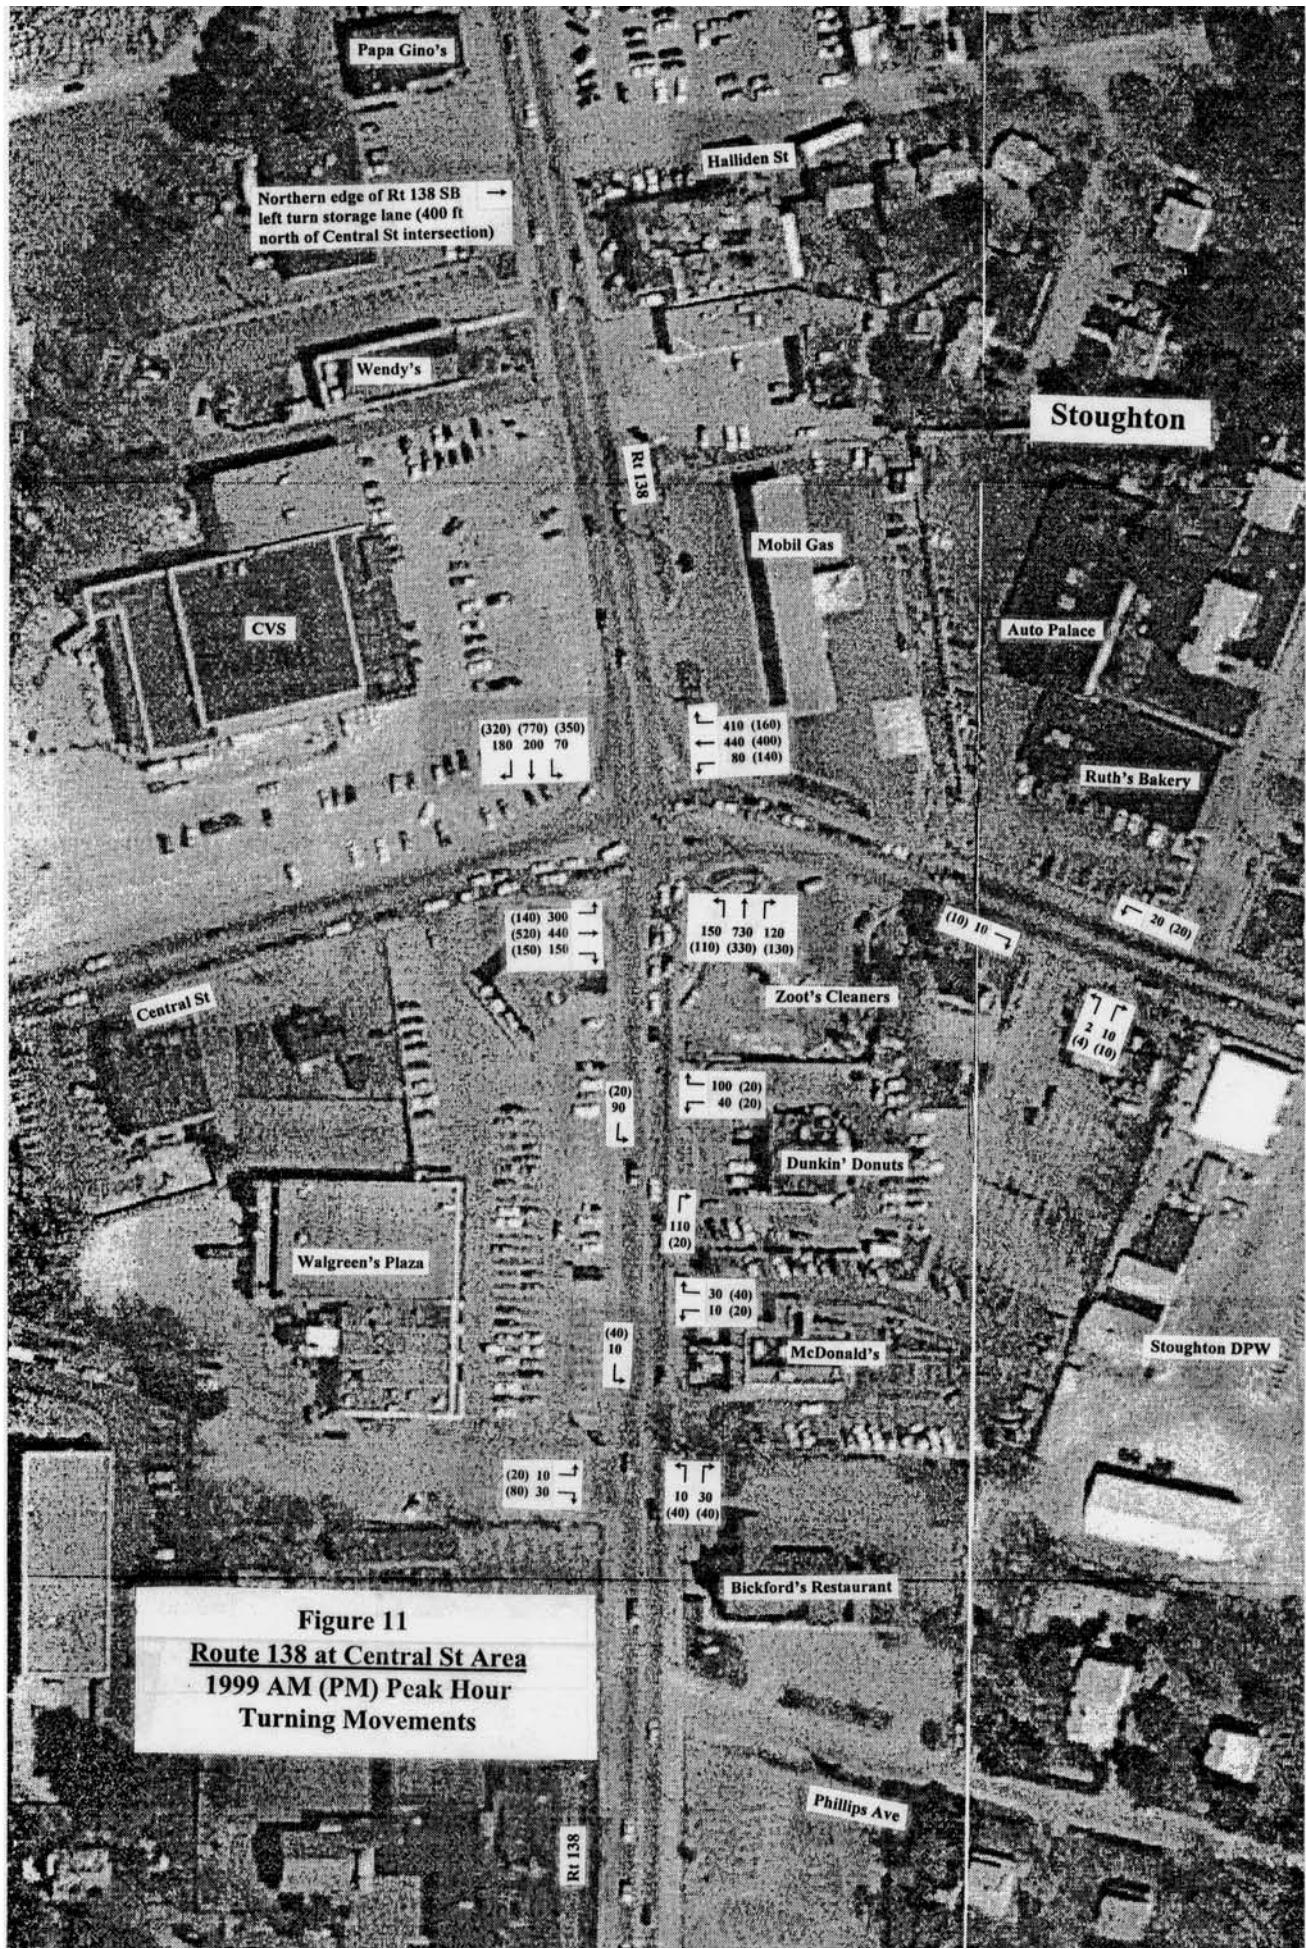
Figure 11
Route 138 at Central St Area
1999 AM (PM) Peak Hour
Turning Movements

Figure 11 shows the AM and PM peak hour turning movements for the intersection and at the driveways of two of the southeast quadrant establishments, Dunkin' Donuts and McDonald's. From manual traffic counts, 130 left turns (90 in and 40 out) were observed at the Dunkin' Donuts driveway (AM peak hour). In order to make these left turns to or from Route 138 southbound, vehicles must first cross three northbound lanes with a combined AM peak hour volume of 1,000 vehicles, causing major interruption to northbound traffic.
